The San Diego County Courthouse Clock Keeps on Ticking *by Rick Coleman*

(From reference material supplied by Verlyn Kuhlmann)

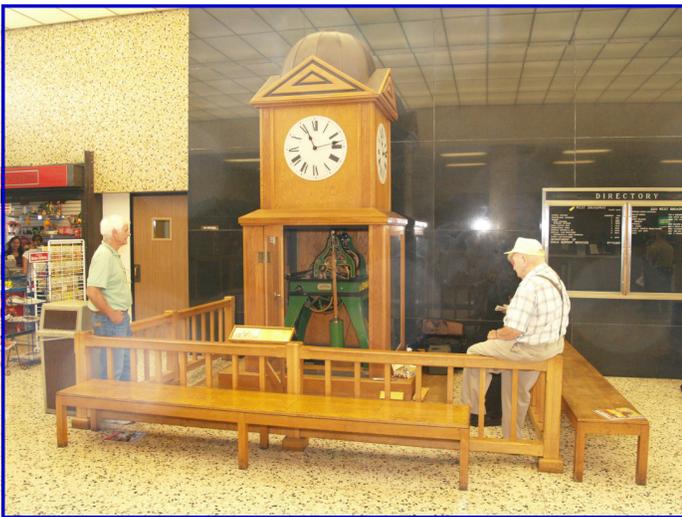
Photo 1 by Rick Coleman

I'm sure everyone in Chapter 59 knows the courthouse clock, that was originally in the old county courthouse built in 1871, was restored by Chapter 59 members in 1980/81. The clock was put back into service in a display "tower" cabinet that was commissioned by the San Diego County Bar Association (see Photo 1). The movement is a Seth Thomas #16, 8-Day Time and Strike constructed in 1890. Because the "tower" on the cabinet is not very high, an automatic rewind motor system was added. Otherwise someone would have to wind the clock several times a day. Only the time train is wound; the strike train is not used. The auto-wind is completely reversible if ever desired to be removed.

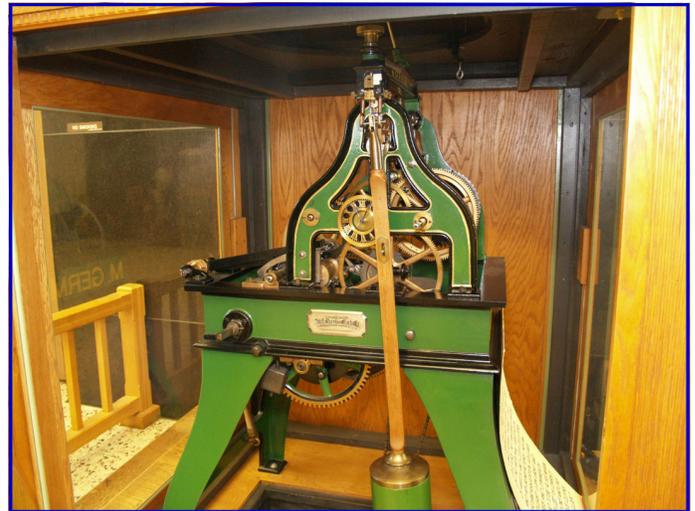
Photo 2 by Rick Coleman

There are two manual winding arbors on the clock, same as a typical time and strike mantle clock. In Photo 2, you can see the two winding arbors. The time arbor is located on the "A" frame section of the clock. It is on the right end of the horizontal beam of the "A". The strike winding arbor is much larger and located on the base frame, left of the name plate. The bell clapper weighed 50 pounds. I can't imagine how heavy that weight must have been.

suspended somewhere between the top and the lowest point of travel. This was obviously not a power outage problem. Each time he re-started the clock it would go for a while and then stop again. The loss of power was due to too much friction in the time train. It's time for an oiling of the clock.

On July 27th of this year Joe Kunkler (Ch 59 & 136), Walt Yahn (Ch 136), Verlyn Kuhlmann (Ch 59 & 136) and myself (Ch 59) went to the courthouse to service the clock. We had to lower the weight down onto wooden blocks using the hand crank. We also removed the pendulum which is also a very heavy item. Walt and I held onto it while Verlyn released it from the suspension point. We were only able to easily remove two of the wheels, the 3rd wheel and the escape wheel. This was accomplished by removing the screw held sleeve bearings at each end of the arbors. These are the brass "disks" that can be seen in Photo 2.

The pivots and bearing sleeves were caked with thick rust colored grease. The grease probably a lot lower viscosity when first applied, but it is very thick after years of use. We wiped all of that old grease off the pivots and the bearing sleeves. Tower clock oil was applied to the pivots. The second wheel had too much extra hardware around one end making it difficult to completely remove without a lot of time. We just cleaned off all the grease that could be reached and applied fresh oil. Joe was watching every move and approved of how the task was done.
